## BMW Engine Breather Assembly Issue

My turbo has failed on my Vehicle and has a BMW Engine.

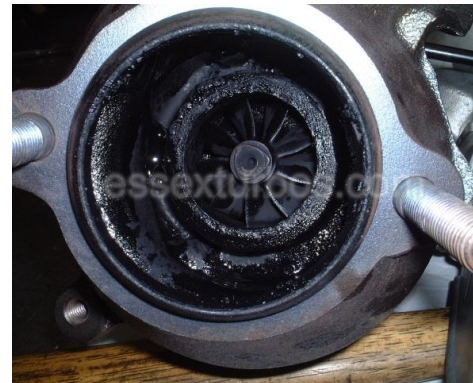
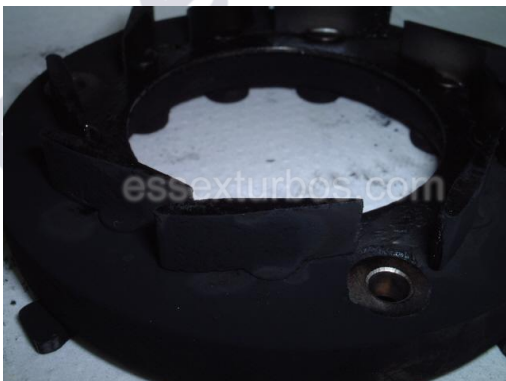
The leaking of oil into the exhaust housing can cause a smoking issue. Also over a period of time the leaking oil can also build up around the variable vanes assembly interfering with their operation.

As the build up of oil carbonises around the vanes they can become what people refer to as 'sticky' vanes which can cause them to operate erratically. The driver may experience issues with the turbo boosting and the vehicle smoking. In some cases the outcome is a destroyed turbo.
